# Check It Out Property Inspections

## CONFIDENTIAL INSPECTION REPORT

3384 Canyon Drive, San Diego, CA 92011

8/16/2006 10:00 am to 12:30 pm

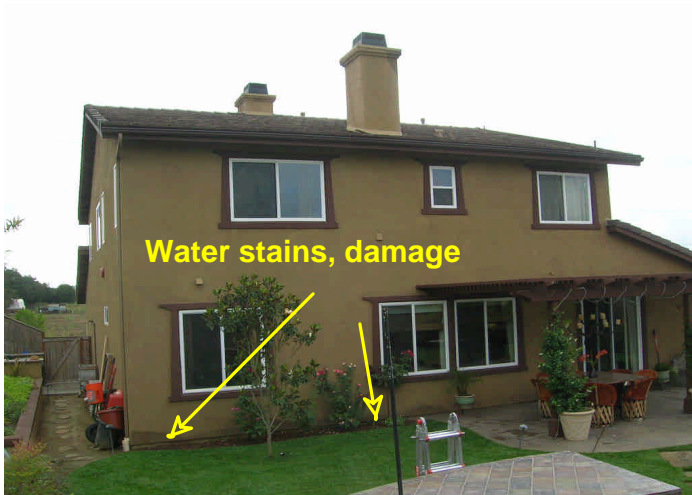
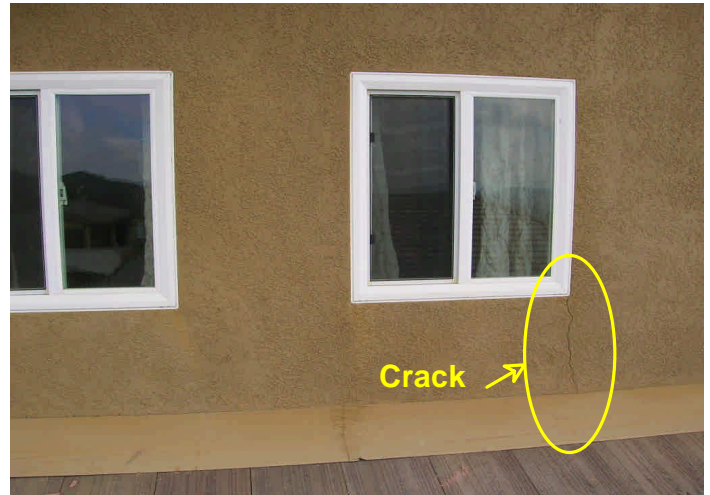
- ✓ Holes or openings in the exterior walls are in need of repair: At right side bottom along weep screed, at rear of house adjacent to planter beds, and at upper (master bathroom) window. The water damage and stains at the base of walls at the rear of the residence indicate uncontrolled run-off

which has deteriorated the finish and begun to cause damage. The irrigation system should be evaluated and adjusted to forestall damage to the wall cladding, and the siding will need repair/refinishing.

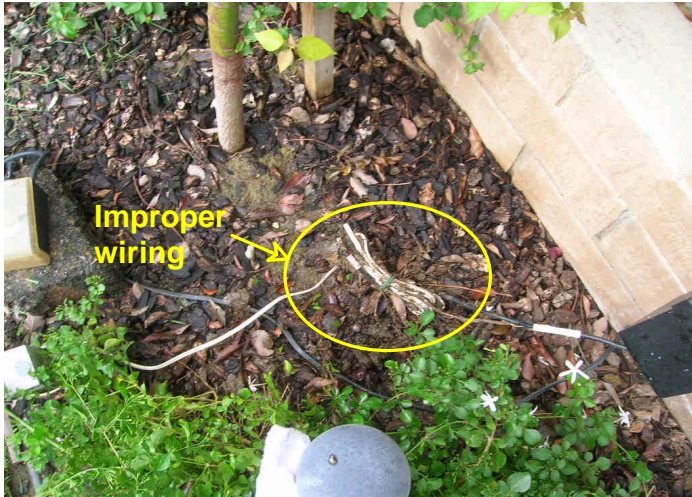
- v The cord/electrical connection supplying power to the timer at rear yard should be properly wired to include wet location wiring and conduit, and a moisture-proof junction box.

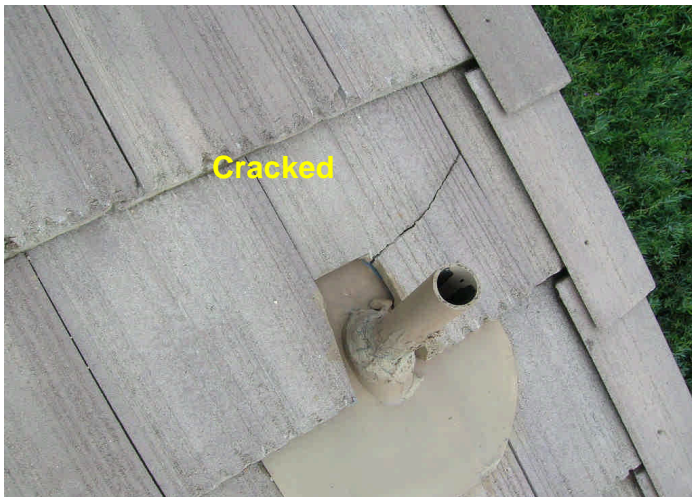
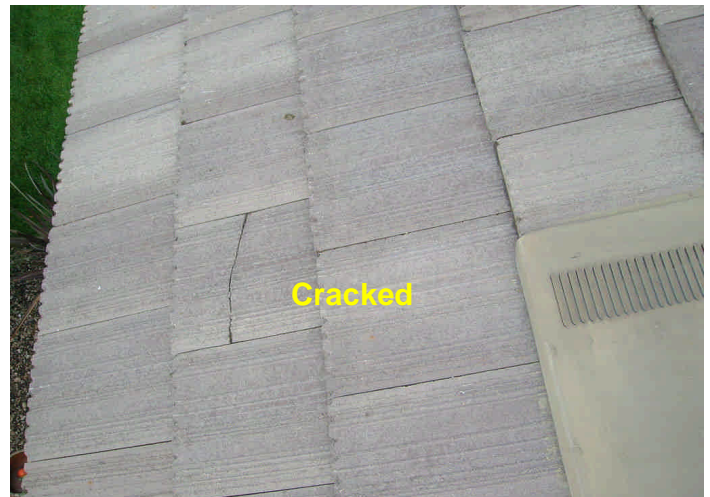
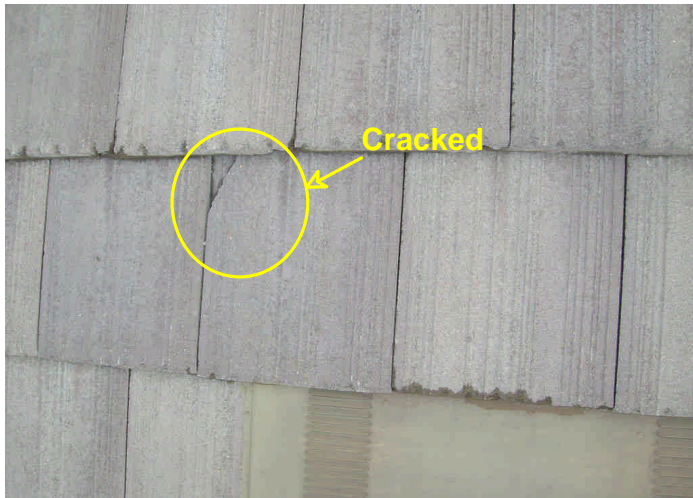
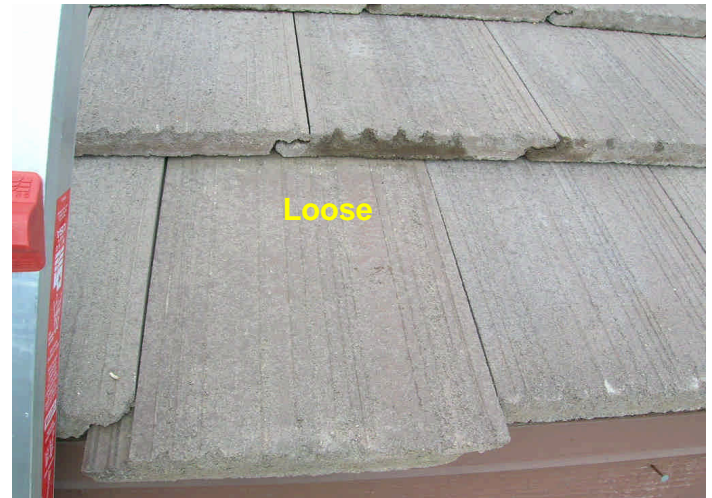
- √ There are cracked or broken tiles that should be replaced. The cracked tiles noted and pictured herein are from the first story roof, however additional similar defects could well exist at the second story roof and complete evaluation and repair of the roofing material, by a licensed roofing contractor, is advised. The inspector may not identify exact numbers of defective tiles or their locations as the inspection is general in nature.

- √ There were loose or unsecured tiles noted. Loose tiles may not only pose a safety hazard, but will expose the roof's underlayment and lead to accelerated deterioration and leaking. Note; Each and every roof tile is required to be positively secured with an industry-approved method. Our inspection is general in nature and each unsecured roof tile and location are not identified. Due to the limitations of our inspection, additional defects may be discovered by a specialist, and a licensed roofing contractor should evaluate the roof and make necessary repairs.

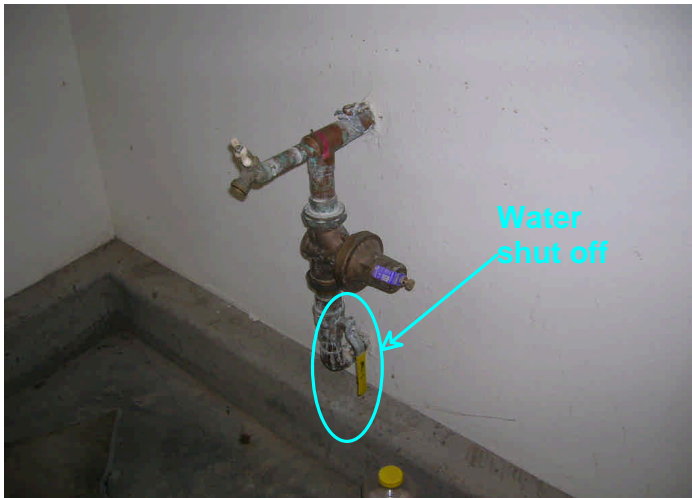
- The main water shut-off valve is located within the garage. The piping material at the valve is copper, size is 1 and 1/4".

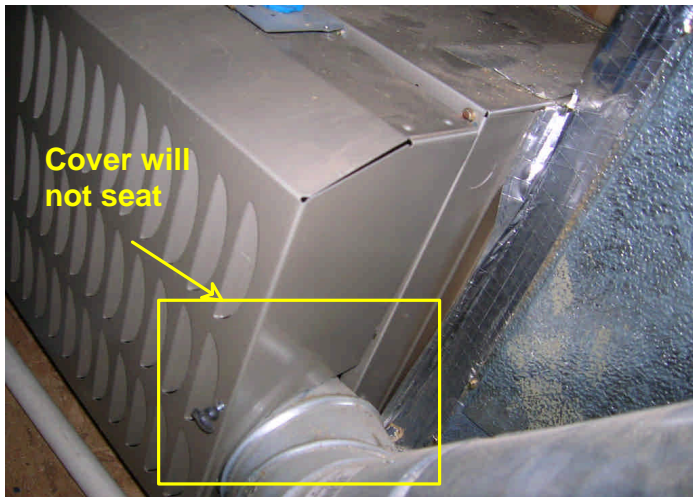
- √ The housing/removable cover of one of the gas furnaces cannot be adequately secured as the vent pipe obstructs the cover from seating properly. Adjustment/repair by a qualified HVAC contractor is advised.

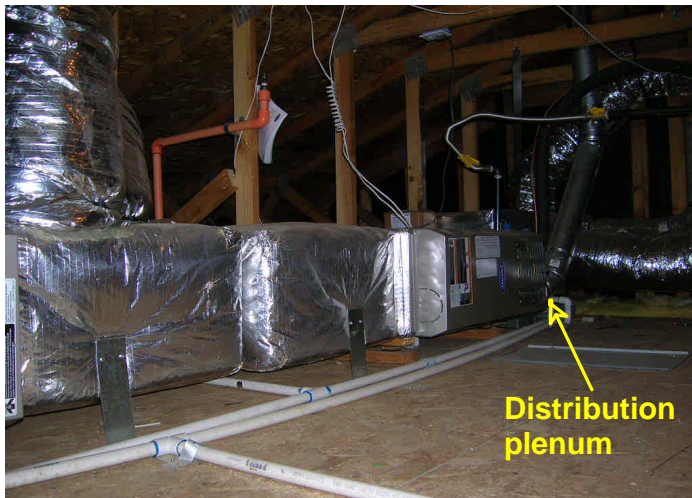
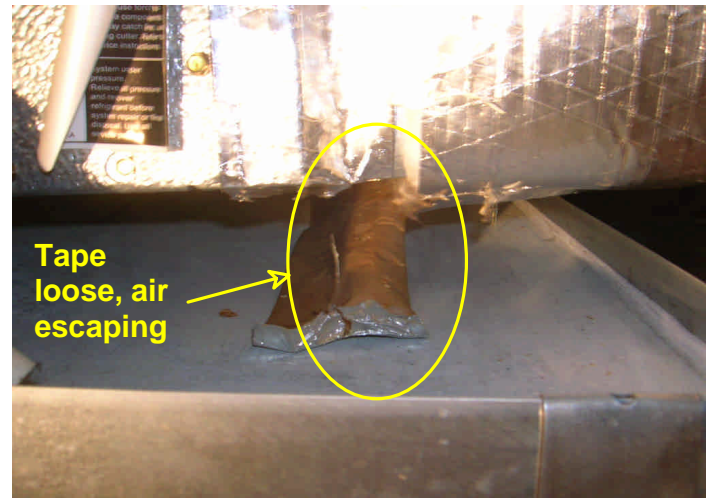
- √ Energy is being lost at the seams of the evaporator coil at the southern/downstairs furnace and air conditioner, which should be sealed.
